GOOD & MAL-PRACTICES

This bulletin aims to present poor and good practices supported by photographic material.

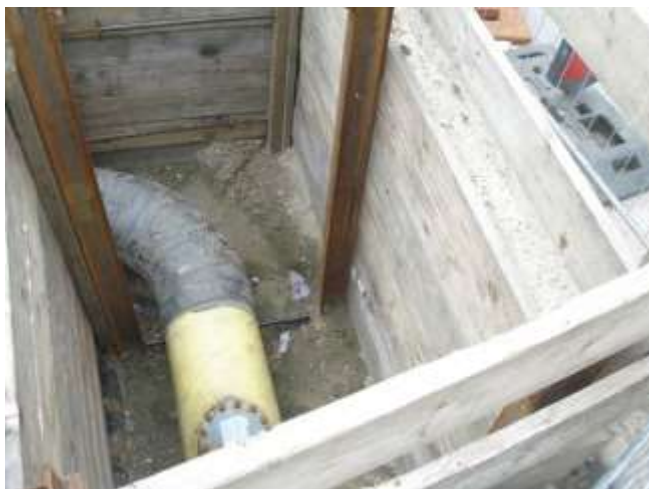
Good Practice

Excavation/
trenching rigid
protection from
wall collapse at a
maintenance
worksite in Berlin.
